Aracruz, JANUARY 12, 2001

HYDROBLASTING

TEST WITH AND WITHOUT PROPRIATORY BÚFALO (KEVLAR®) PROTECTION SUIT

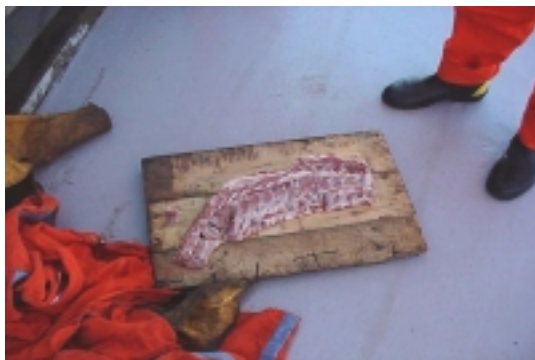
Photo 01 – Pig rib was fixed with nails to a wood table

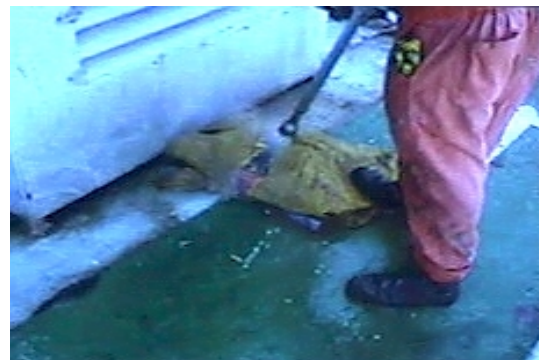
Photo 3 – Passing the rotary gun over the test with 0,083m/sec (0,3 Km/hr)

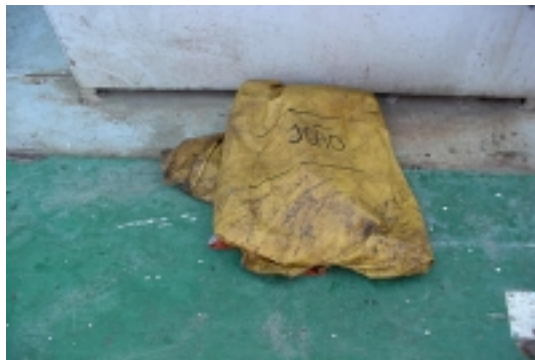
Photo 02 – Pig rib covered with sail cloth Kevlar® suit and yellow PVC cloth. We named the test speciman:John (João)

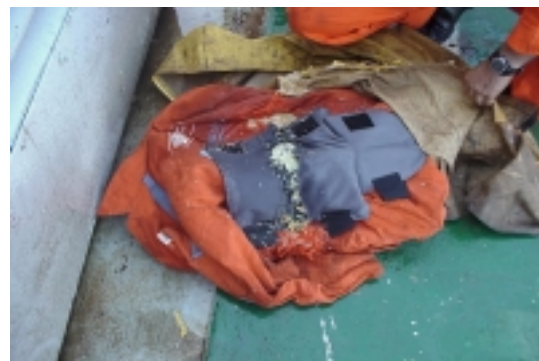
Photo 04 – After UHP jetting , the PVC cloth, was destroyed. First and second layer of Kevlar suit has been cut. (Total of 7 Kevlar layers)

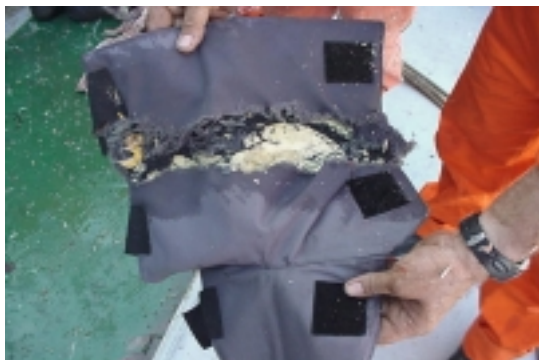
Photo 05 – A closer view of the Kevlar suit

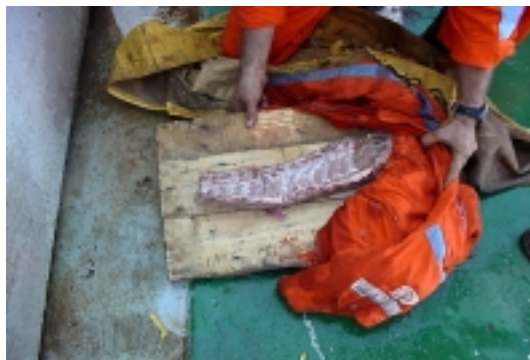
Photo 07 – John (João), our pig rib, is safe....
The rib without damage

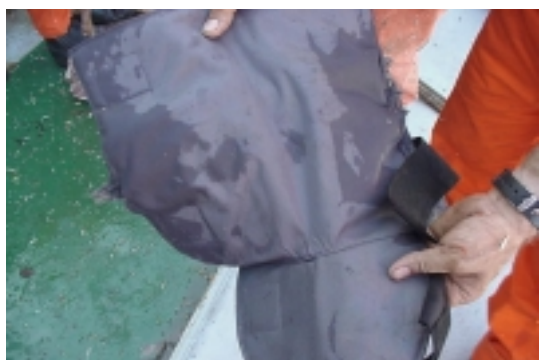
Photo 06 – The interior side of the Kevlar suit:
We observe no destruction, only wet.

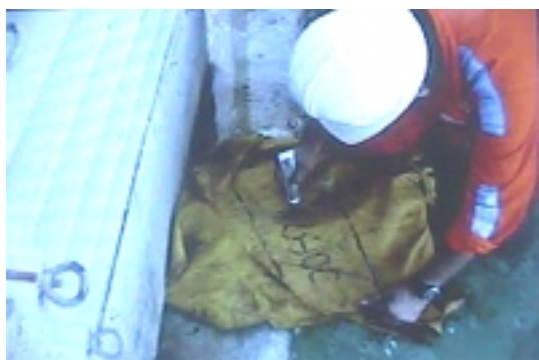
Photo 08 – Preparing the test , only PVC and
sail cloth protection

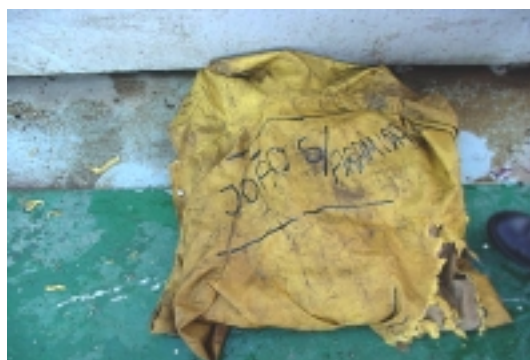
Photo 09 – John (João) is prepared for the
UHP test using only PVC and sail cloth

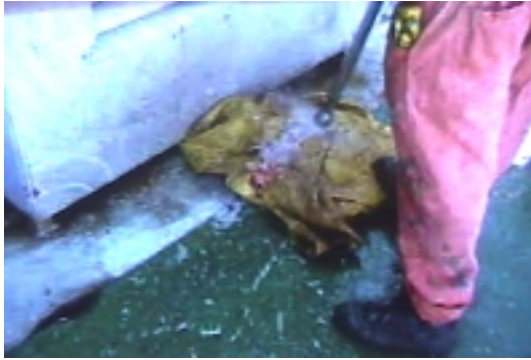
Photo 10 – Passing the UHP gun over the test

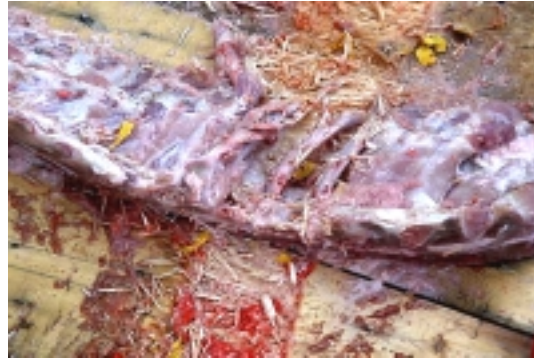
Photo 13 – We see about 5 millimeter cut of the wood table

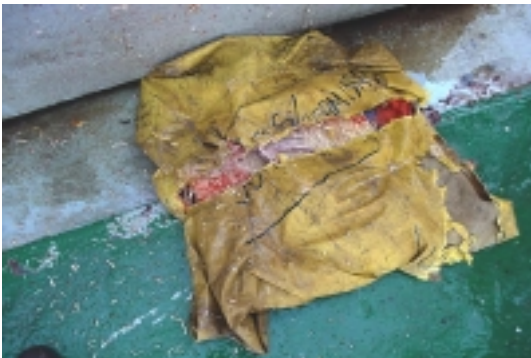
Photo 11 – Total cut over PVC and sail cloth and also cutting all the flesh

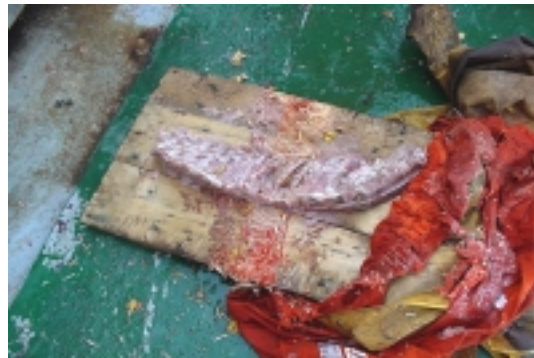
Photo 14 – We announce condolences from our nice friend John, the pig rib.
Inform of the medical Institute:
John, 24 years old died today in this hospital.
This heart , right lung were seriously damage with aprox. 0,8 lts of water at a velocity of 2210 Km/hr

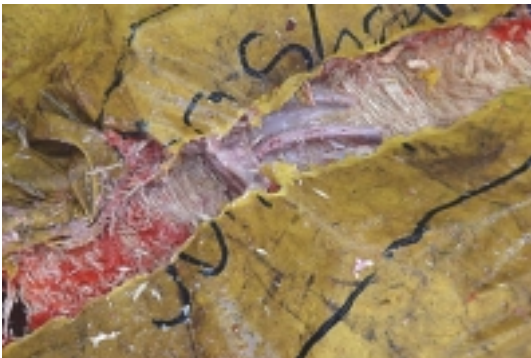
Photo 12 – Closer
